# Manhole Inspection Summary

Manhole # S49A\_\_054MH

Insp Date: **5/7/08 11:14 AM**

**Location** Address: **500 n lakewood**

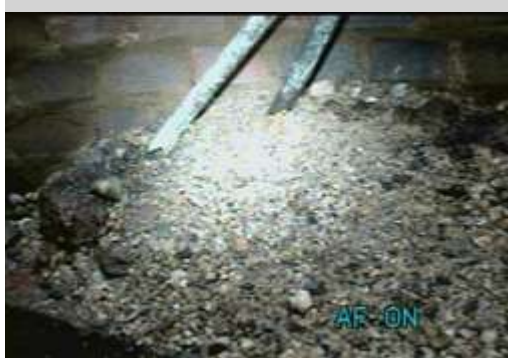
Defect 3

Condition: ☐ Sound ☐ Cracked ☐ Root Intrusion ☐ Deteriorated ☐ Leaks ☒ **Debris**

bench debris

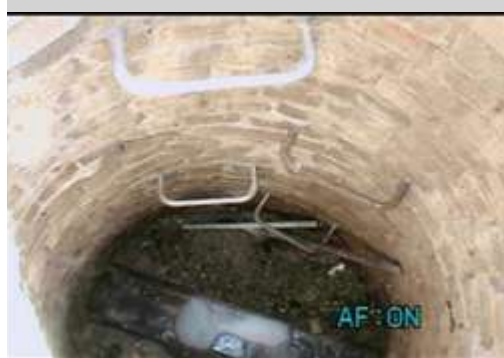
Defect 2

Count: **4** Missing: **0** ☒ **Corroded**

steps

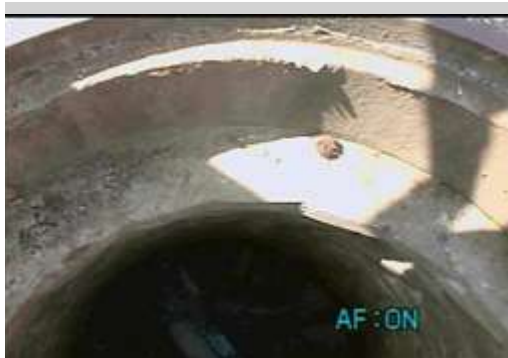
Defect 1

Offset: **4** (in.)

offset

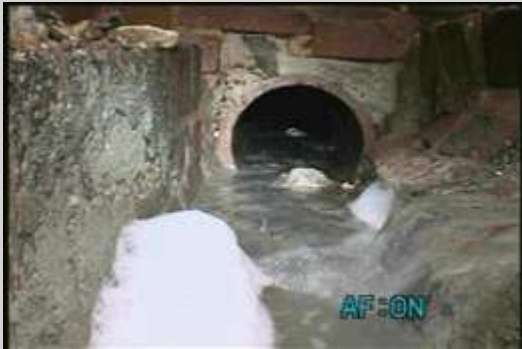
12 O'Clock Outflow

8 in. Circular Gravity Sewer  
Pipe Out @ 12 O'Clock

Deposits: ☐ None ☐ Mud ☐ Sludge ☒ Debris ☐ Grease

Silt Depth: 2 (in.) Deposits Extent: **Medium**

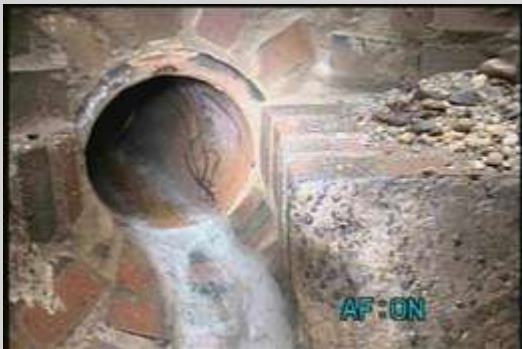
3 O'Clock Inflow

8 in. Circular Gravity Sewer  
Pipe In @ 3 O'Clock

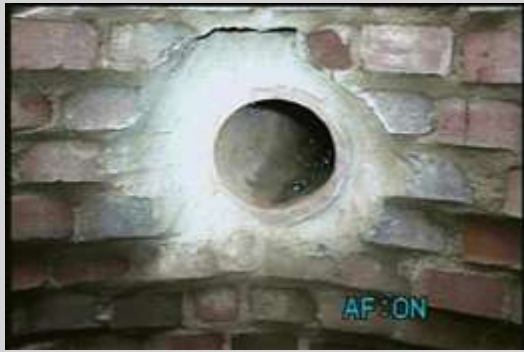
6 O'Clock Inflow

6 in. Circular Gravity Sewer

Pipe In @ 6 O'Clock

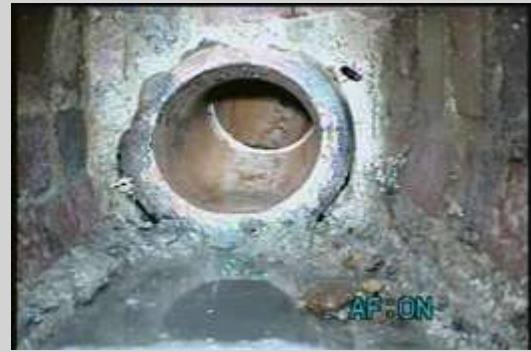
Drop In @ 6 O'Clock

Drop: **Outside Direct**

Drop Condition: **Open**
